Airfield Damage Repair Modernization Program

Validation of FRP Matting Requirements

Final report

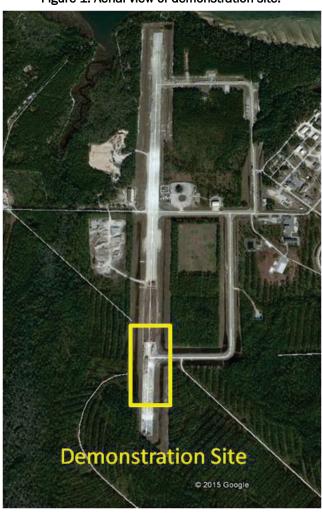
Figure 1. Aerial view of demonstration site.

The work described in this document was performed on the south end of the PCC runway of the Silver Flag Exercise Site, Tyndall AFB, Florida, as indicated in Figure 1. This area has been frequently used for demonstrating crater repair technologies. Therefore, many of the pavement slabs were previously disturbed. Locations within the test area were identified that would allow for performing the necessary repairs with ample room to apply simulated traffic.

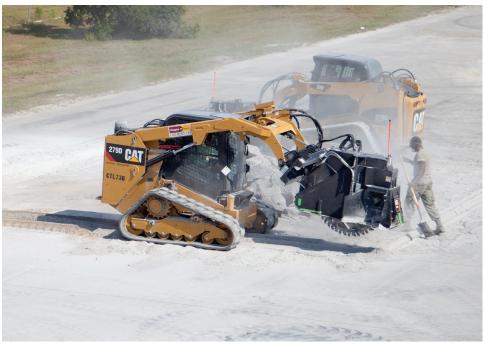
Figure 3. CTL with wheel-saw attachment.

Caterpillar 279D rubber-tracked compact terrain loaders (CTLs), also known as skid steers, were used during the demonstration. The CTLs had high-flow hydraulic systems capable of operating the ADR attachments. A Caterpillar SW45 wheel-saw attachment (Figure 3) and a 78-in. bucket attachment (Figure 4) were the primary tools used in the crater repair process. Wheel saws were used to rapidly cut the pavement surrounding the crater for a square-shaped repair. The bucket attachment was used for debris removal during the excavation process.

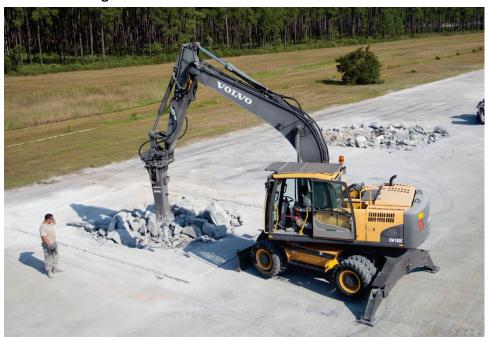
Figure 5. Wheeled excavator with breaker attachment.

Two Volvo EW180D wheeled excavators were used as part of the crater repair process. One was equipped with a HB1400 chisel-tipped hammer attachment (Figure 5) and was used to break PCC from within the repair area. The other was equipped with a 36-in.-wide toothed bucket (Figure 6) and was used for removing broken PCC and underlying material.

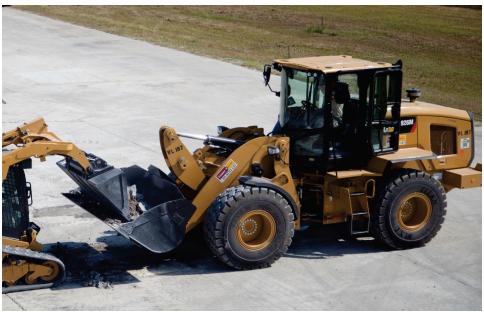
Figure 7. Front-end loader.

A Caterpillar 926M front-end loader was used to load and transport crushed stone for the crater backfill (Figure 7). For the larger craters, stone was loaded into dump trucks that backed near the crater and dumped the crushed stone directly into the crater. For small craters, the front-end loaders were used to transport the stone for placement in the crater.

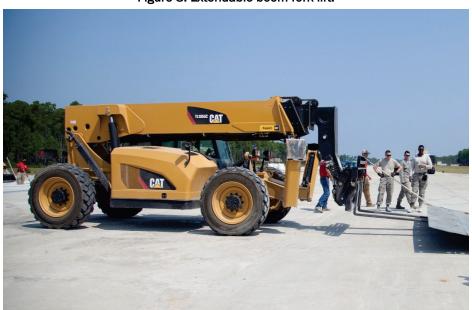
Figure 8. Extendable-boom fork lift.

A Caterpillar TL1055C extendable-boom fork lift was used to transport the matting systems (Figure 8). Additionally, a Caterpillar 10E913 forklift was borrowed from Silver Flag to assist with handling FFM matting. This forklift was used in training of the legacy system by Silver Flag. The two forklifts were used side by side for loading and unloading FFM. For FRP matting, the TL1055C was used to load/unload mats and to support the matting assembly as pieces were being unloaded during assembly.

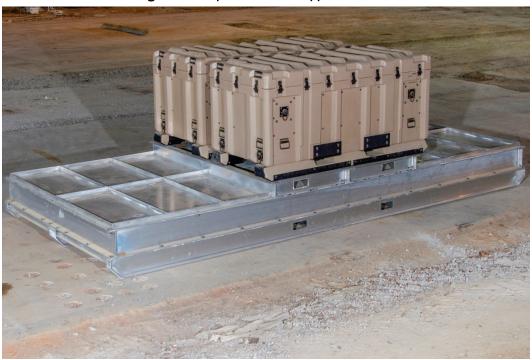
Figure 9. Complete FRP air-droppable mat kit.

The complete FRP air-droppable mat kit, shown in Figure 9, was designed to be a scalable system that can support multiple crater dimensions and shapes. The kit was comprised of three main components, i.e., the prototype FRP mat container with FRP mat panels (contents in Table 2), a container with consumable materials (contents in Table 3), and a container with installation tools (contents in Table 4). The kit was designed so a single installation tool set could support multiple mat and consumable packages. The consumables and installation tools are packaged in two Hardigg 16848-100 Air Drop Boxes. The FRP panels were packaged in a prototype FRP mat container designed to function as a palletized skid that can be attached to a 20-ft, Type V airdrop platform. The two Hardigg 16848-100 Air Drop Boxes together with the prototype FRP mat container form a single air droppable kit. Each kit is capable of providing a FOD cover for 13 5-ft-diameter craters, five 10-ft-diameter craters, three 15-ft-diameter craters, or one large crater up to 28-ft diameter.

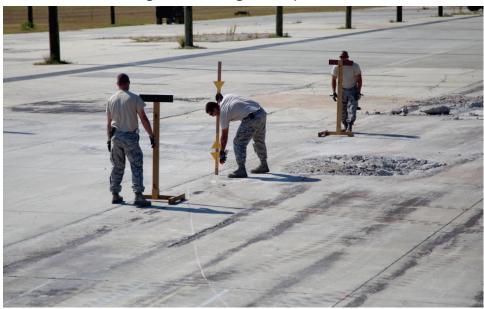
Figure 11. Marking crater repair area.

For the exercise, the equipment operators deployed to the crater site in the required equipment. The team cleared peripheral debris, identified the required repair area, and marked square lines for cutting (Figure 11). Two CTLs with the SW45 wheel-saw attachments then began to simultaneously cut parallel lines in opposite directions (Figure 12). After completing the first cuts, the CTLs were repositioned, and the adjacent parallel lines were cut with the saws operating in opposite directions.

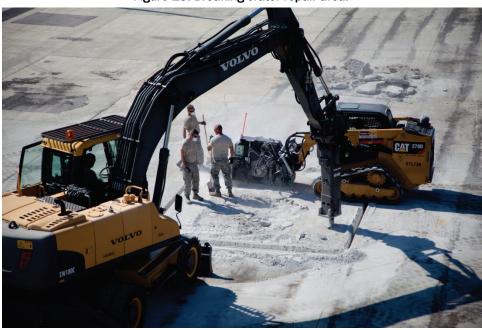
Figure 13. Breaking crater repair area.

Once cutting was complete, the Volvo excavator with the breaker attachment was used to break the PCC surface into bucket-sized pieces by repositioning the breaking head on the pavement surface (Figure 13). Once complete, the Volvo excavator with the bucket attachment was used to scoop the chunks of concrete and place them adjacent to the crater (Figure 14). The operator continued to excavate the crater until the depth was uniform and at least 18 in. below the pavement surface.

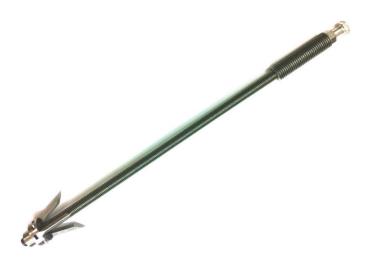
Figure 22. Tri-Talon anchor schematic.

Each anchor consists of (from bottom to top) a retaining ring, the Tri-Talon, the threaded anchor rod, the special anchor coupling (connecting the rod and anchor bolt), and the anchor bolt. Detailed drawings of the Tri-Talon anchor system are in Rushing et al. (in preparation.) The primary advantage of the Tri-Talon anchor system is its use of the entire pavement structure to resist vertical pull-out. Figure 22 shows an overall schematic of an installed Tri-Talon anchor.

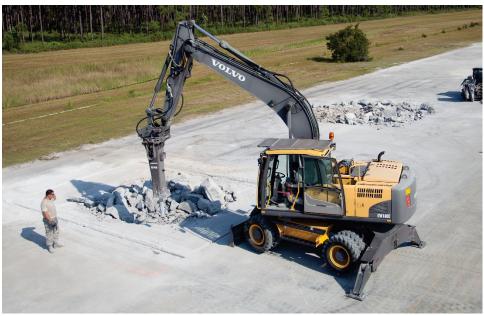
Figure 23. Large crater repair area.

Breaking the upheaved pavement was accomplished using the Volvo Wheeled Excavator with the breaker attachment (Figure 23). The goal of the breaking process was to fracture the upheaved pavement surface into manageable pieces that could be removed using the excavator with a bucket attachment or the CTL with a bucket attachment. Table 6 provides the timing data from the breaking procedure for each crater.

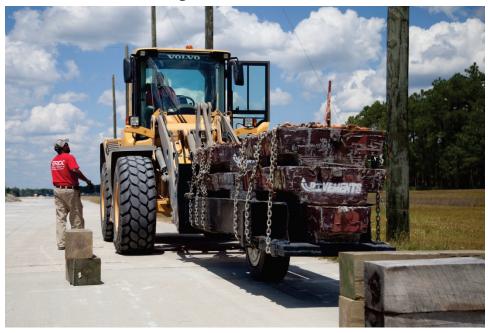
Figure 24. F-15E load cart.

A specially designed single-wheel load cart was used to simulate F-15E aircraft traffic. The load cart was equipped with a 36-in. by 11-in. tire inflated to 325 lbf/in.² and loaded such that the test wheel was supporting 35,235 lb. A photograph of the load cart is shown in Figure 24.

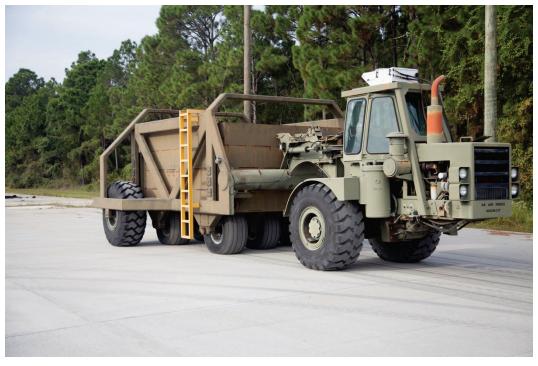
Figure 25. C-17 load cart.

The multiple-wheel C-17 load cart was designed to exactly match one-half of the full main gear of a C-17 aircraft. The multiple-wheel C-17 load cart was equipped with six 50 in. x 21 in. tires inflated to 142 lbf/in². The cart was loaded with lead weights so that the test gear was supporting approximately 269,000 lb. A photograph of the load cart is shown in Figure 25.
